# Port Augusta Operations Ambient Monitoring Network

Ambient Air Quality Monitoring Validated Report

1st August – 31st August 2025

Report No.: DAT23258

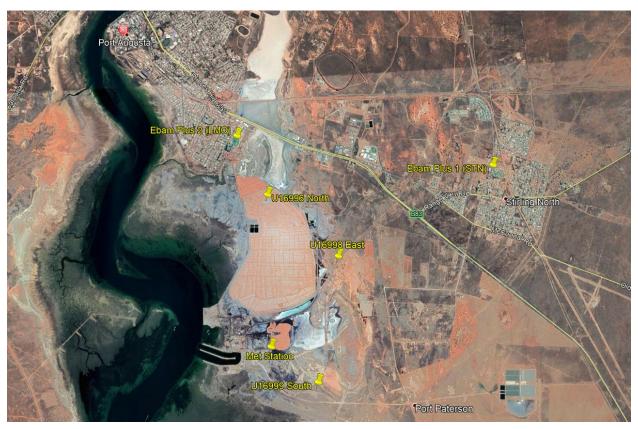
**Figure 1: Port Augusta Operations Monitoring Station Locations**

- Measurement of PM<sub>10</sub> via E-Samplers is not covered by Acoem's NATA scope of accreditation.
- Siting of PM<sub>10</sub> via Exactus BAM plus 1 (STN) and Exactus BAM plus 2 (LMO) does not fully meet
  the recommendations of standard AS/NZS 3580.1.1:2016 due to the stations being located in
  close proximity to a shed and roadway.

- Siting of PM<sub>10</sub> via Exactus BAM plus 2 (LMO) does not fully meet the recommendations of standard *AS/NZS 3580.1.1:2016* due to a nearby dirt track and Hivols located around 1.2m from the unit.

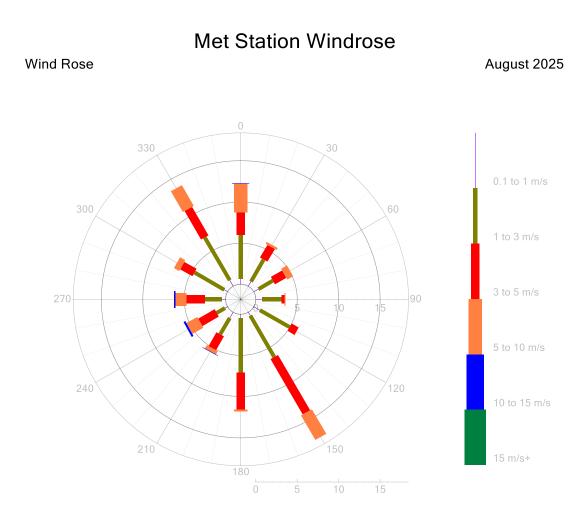
**Figure 2: Met Station Wind Rose**

0.1% calm 100.0% valid data present

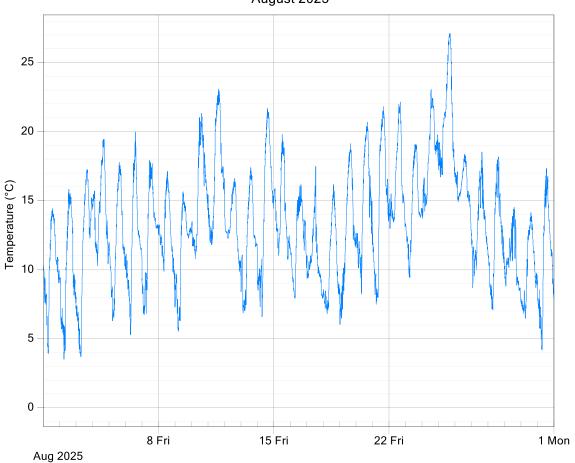
Figure 10: Met Station Ambient Temperature 5-Minute Averages<sup>3</sup>

<sup>&</sup>lt;sup>3</sup> The data for ambient temperature is for reference only as the calibration checks failed and could not be adjusted due to logger connectivity issues.

Start Date	End Date	Reason	Change Details	User Name	Change Date
01/08/25 00:00	01/09/25 00:00	The calibration of the temperature sensor could not be adjusted to produce a pass. Therefore, the data is for reference only.	AT	AN	25/09/25
15/08/25 11:00	15/08/25 11:10	Scheduled monthly maintenance - Rain gauge cleaned	Rain	AN	25/09/25
